A summary of salt marsh restoration, Waikawa Estuary, Marlborough

Prepared for
Marlborough District
Council
August 2021

Salt Ecology
Report 081

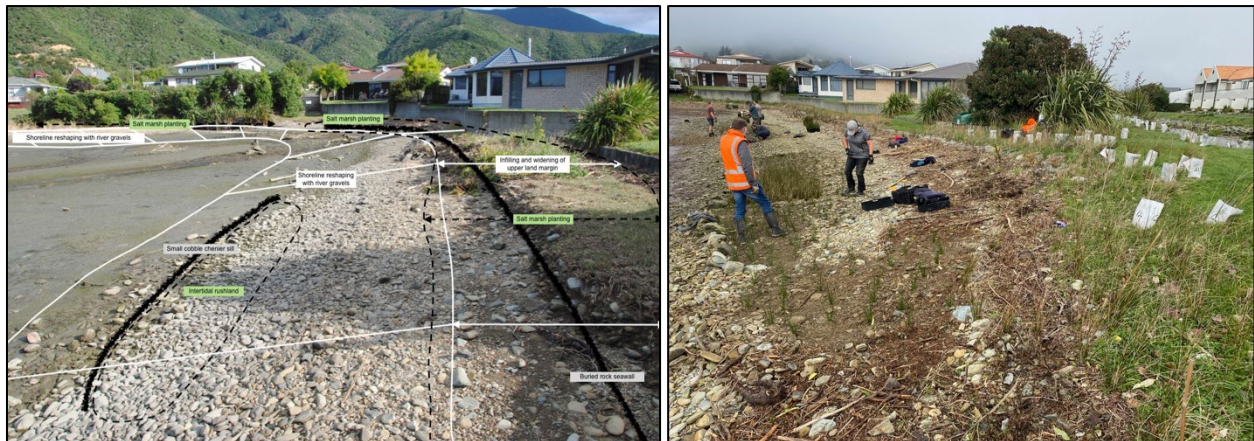
Schematic outline of the restoration area prior to development (left) and post-restoration reshaping and planting (right)

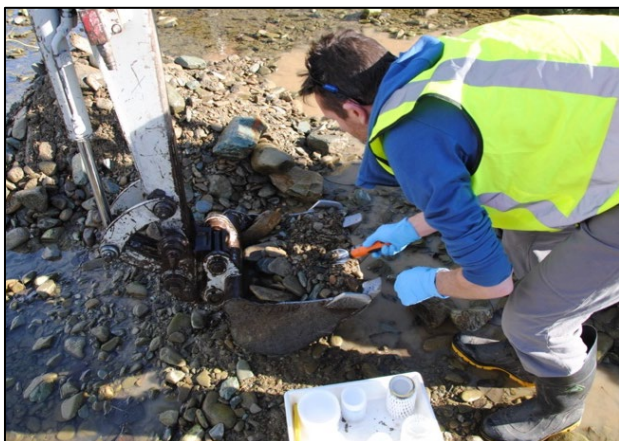
Excavating test pits in Waikawa Stream to assess sediment composition and test for the presence of contaminants

Representative sediment samples were analysed by RJ Hill Laboratories for a suite of common indicators of physical or contaminant conditions, e.g. % mud/sand/gravel, total organic carbon, trace metals, semi-volatile organic compounds, tributyl-tin, and total petroleum hydrocarbons. Results showed that sediments contained no contaminants at concentrations known to pose any ecological risk. The streambed sediment was also considered appropriate for use in shoreline reshaping and restoration of salt marsh habitat with a low mud content (<2%) and a mix of larger grain sizes.

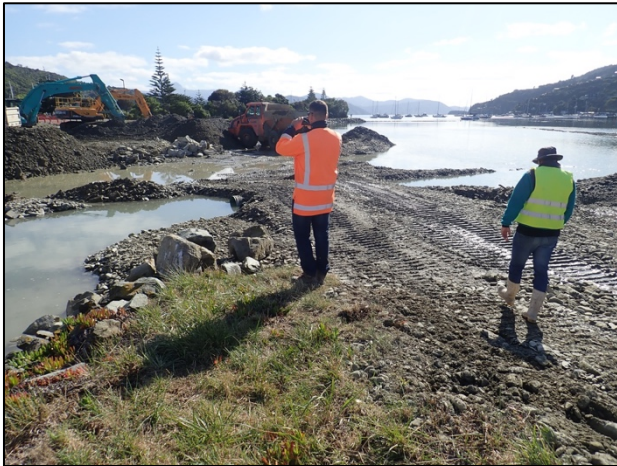
Bunds separated the work site from the estuary to prevent off-site sediment impacts. Stream flow was maintained through a pipe passing through a silt trap (foreground).

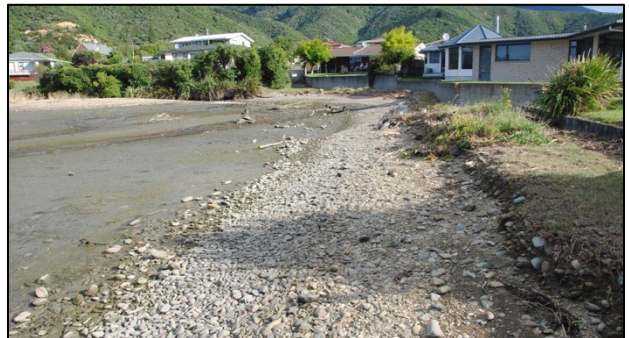
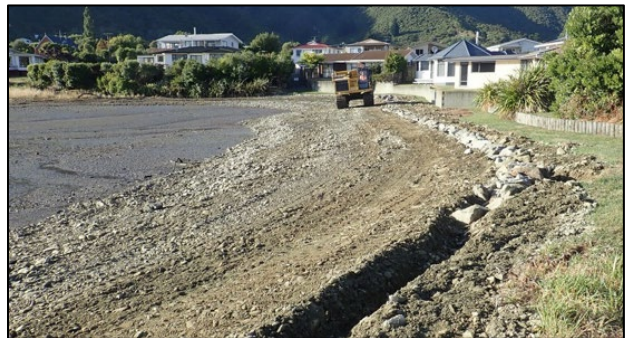
Before and after photos of the primary work site showing the extent of beach replenishment and buried erosion wall

Initial reshaping work on the first day of construction was supervised with feedback provided by MDC, Salt Ecology and iwi representatives. This included delineating the shoreward extent of the earthworks for beach reshaping, and the location of the buried rockwall for erosion protection (see photos below).

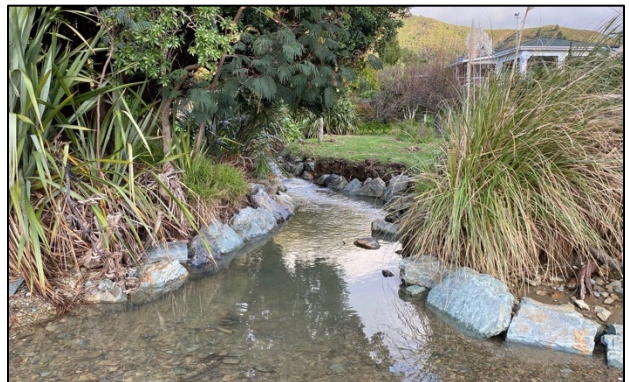
Modified stream entrance with rock placement to minimise erosion

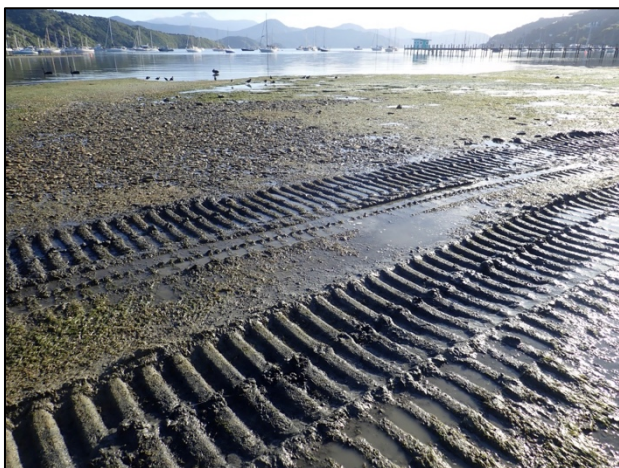
Vehicle tracks through seagrass beds. While resulting in relatively minor impacts, such effects were largely avoidable.

There were also situations where additional on-site contractor supervision would have proved beneficial. For example, the widening of the upper shoreline and terrestrial margin area in the south of Zone 1 (see Fig. 2) was greater than depicted in the site plan and also resulted in the unintended compaction and burial of small areas of rushland and seagrass. There were also impacts from machinery tracking through seagrass beds to gain access around the shoreline. While the effects were relatively minor and short-lived, the impacts were largely avoidable through more thorough marking of site boundaries and profiles or direct on-site supervision.

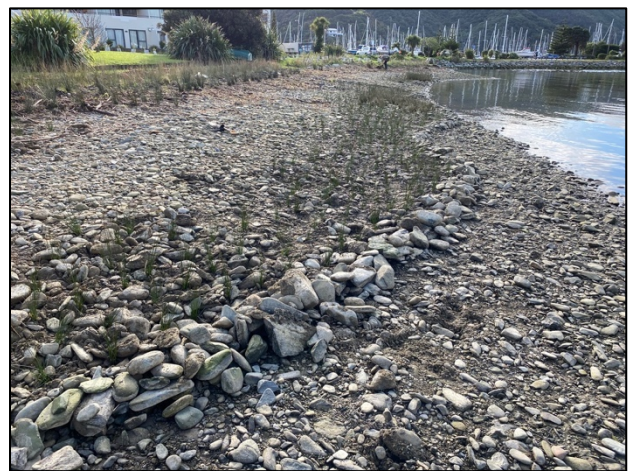
Chenier rock sill seaward of freshly planted searush

Once intertidal planting zones were marked out, surface cobbles were cleared from the beach surface and used to create small chenier sills on the seaward margin of the planting zone (see following photo). These sills protect plantings from wave erosion and facilitate the trapping of finer sediments. Existing beach contours were followed, or curves created, to help deflect wave energy and ensure chenier sills maintained a natural appearance. Because of the relatively small size of the cobbles used to construct the cheniers, ongoing movement is expected and occasional site maintenance likely to be needed following storm or flood events.

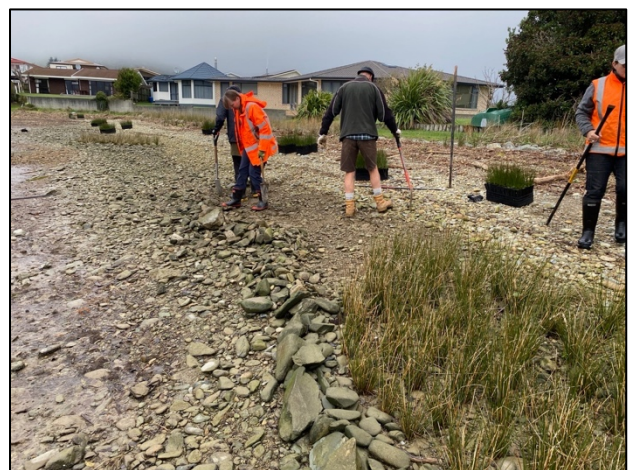
Clearing surface cobbles to create chenier sills and prepare site for planting

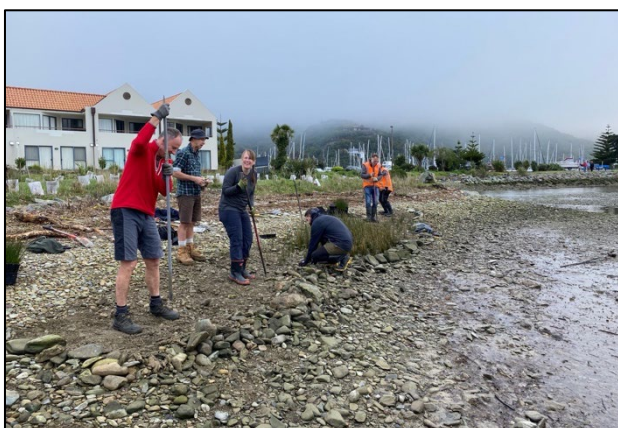
Using crow bars to create deep narrow planting holes behind the rock chenier in the upper intertidal zone

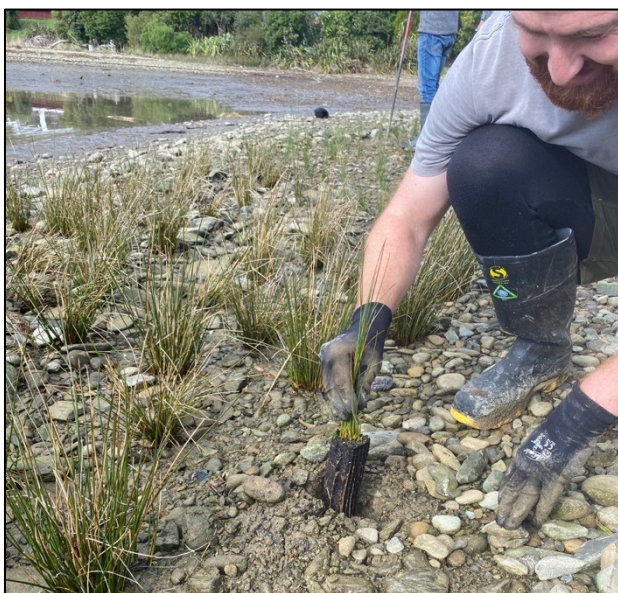
Intertidal searush was planted at a high density to facilitate rapid infilling and minimise erosion losses

To facilitate rapid infilling of plants to minimise erosion losses, 900 salt-tolerant rushes (Table 1) were planted at a high density (10-15 plants/m², spacings ~20-25cm). Crow bars were used to create deep, narrow holes for planting (see following photos). Root trainer plants had the roots loosened before being firmly bedded in the substrate ensuring that the base of the plant stem was buried within

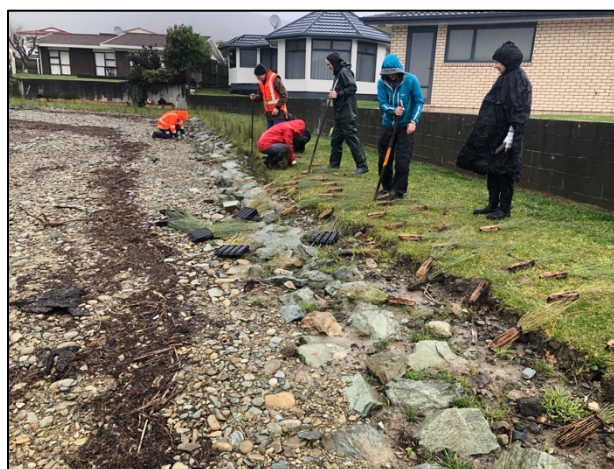
Plants laid out ready for planting on the terrestrial margin

Plants were initially laid out in the locations they were to be planted and then teams of two worked through the site one digging the hole, and one placing and packing the plant and installing the tree guard.

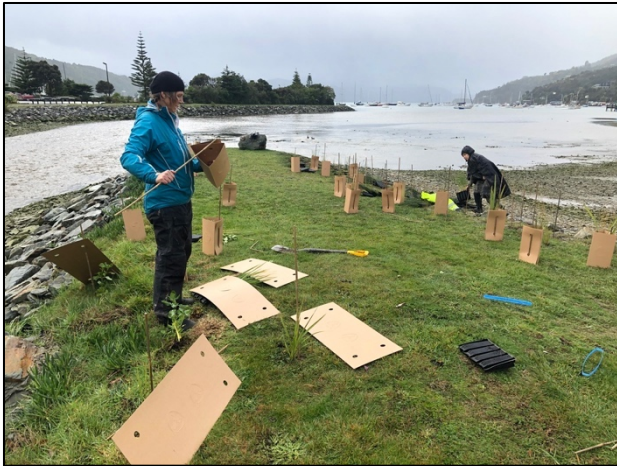
Folding and installing EmGuard plant guards

Plant guards provide essential protection to young plants. The biodegradable cardboard EmGuards used were simple, effective and proved durable over the 12 months they have been in place.

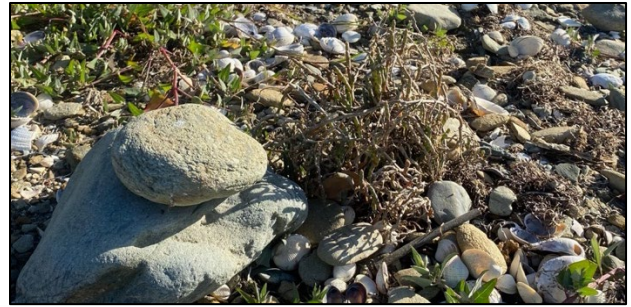
Glasswort divot planted in the upper tidal range

Glasswort was planted in the upper intertidal zone as this species, once likely common in the estuary, was no longer present. It is a very hardy plant and can rapidly re-colonise from existing beds as it grows well from beach-cast fragments. It was hoped that re-establishing this species would facilitate its natural spread. Two approaches were taken. Approximately 90 small plants with active roots were teased apart from larger clumps and planted along the upper strand line, along with 10 larger divots (~20x20cm) containing a group of stems and largely undisturbed root section - see following photo.

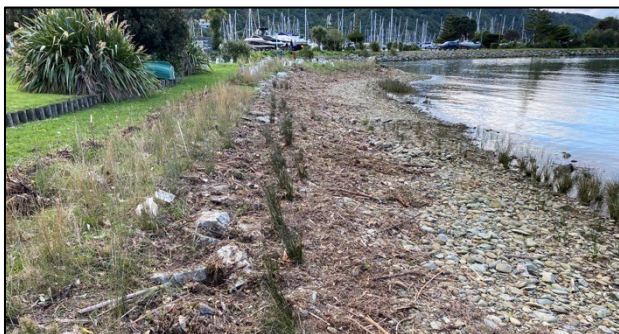
Upper swash zone showing residual organic debris after site clearance. The dark green rushes in the middle of the picture were all buried, but quickly recovered once cleared

Overall, nursery supplied plants had very low mortality. Within intertidal areas, there was no discernible loss of searush to desiccation or erosion. In the upper swash zone, beach-cast material, in particular seagrass fronds and leaf litter washed downstream from terrestrial areas, periodically smothered some of the searush and oioi plantings. This impact was patchy and uncovering of plants during site maintenance indicated that most plants were able to survive short periods of burial and were able to subsequently recover.

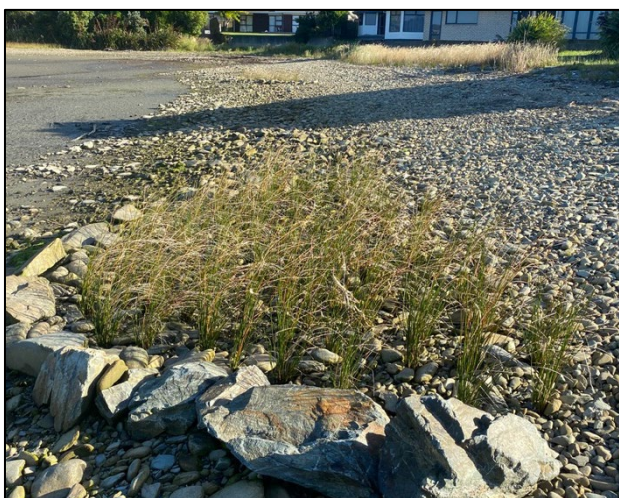
Dense searush beds with closing canopy cover

Intertidal rushland was very successful. Within 6 months, beds were well established and were forming a canopy cover. Finer sediments were beginning to accumulate within the beds, and the chenier sills had proven to be relatively stable requiring little maintenance.

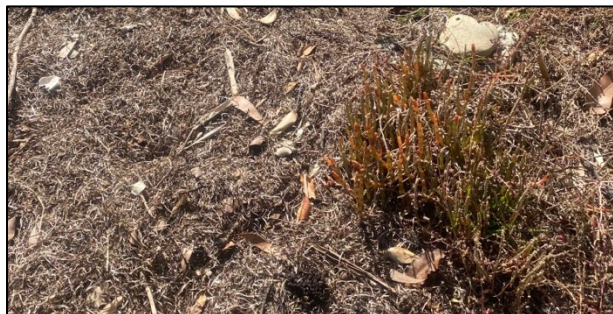
Transplanted glasswort divot

Glasswort, transplanted from a nearby estuary, was the least successful of the intertidal plantings. Several of the larger divots survived, but most of the smaller plants that

had been separated out and planted individually did not. It was unclear whether plants had died as a consequence of transplanting stress, desiccation, erosion or smothering by debris.

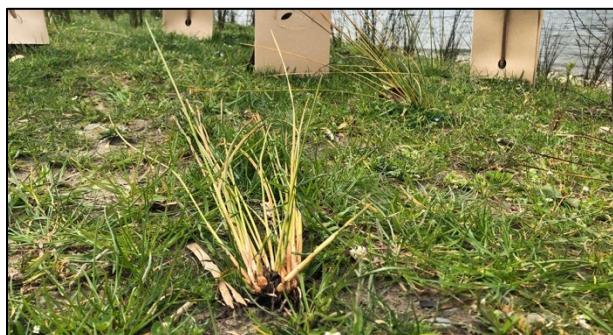
Collapsed knobby clubrush one month after planting

In terrestrial areas, knobby clubrush collapsed within 1 month of planting and ~50% were subsequently lost. Of the other terrestrial shrubs, ~95% appeared to have survived, despite a dry and hot summer following the mid-winter planting. Losses were largely attributable to overgrowth in weeds over the summer (see following section).

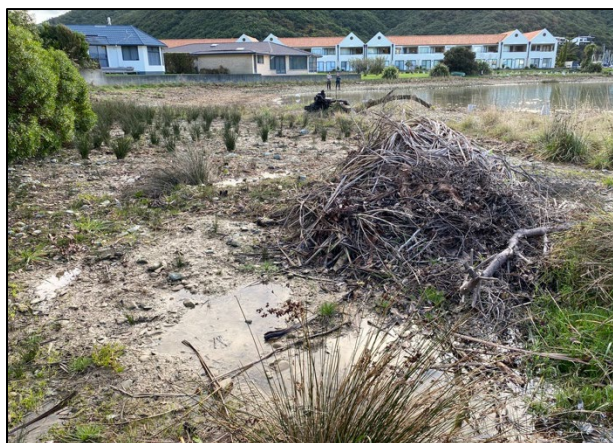
In Zone 2, there was also damage to plants from the dumping and burning of green waste in the estuary, from grass mowing and the parking of boats and vehicles in the planting zone.

Green waste dumped in the middle of estuary restoration plantings

Marking the site boundary of Zone 2 with temporary fencing or signage, and ensuring green waste dumping and burning is discontinued, is also recommended.

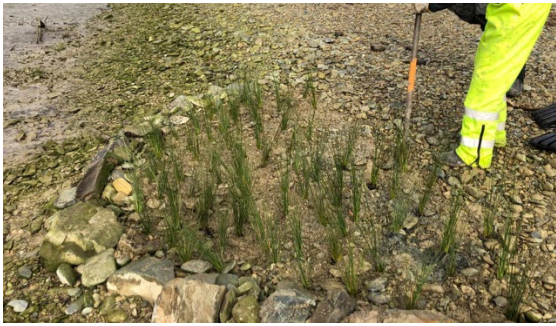
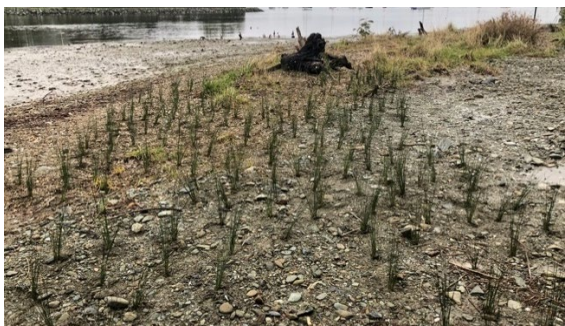
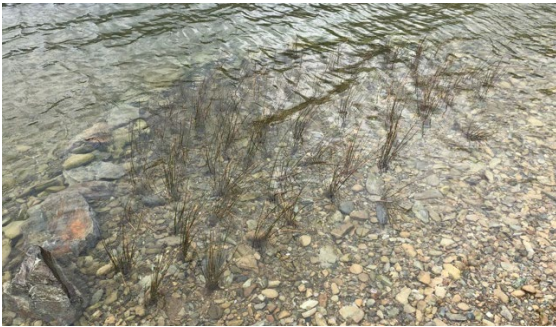
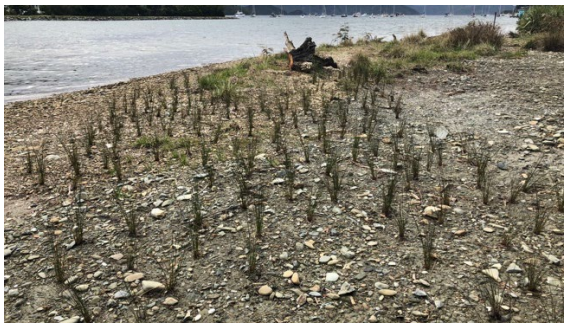
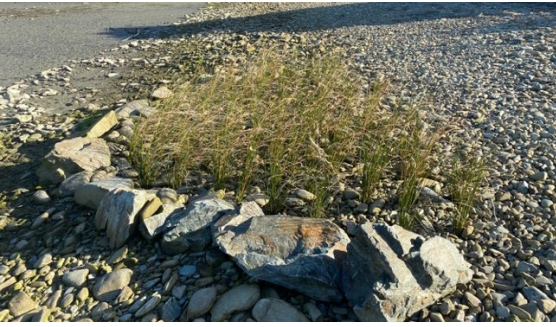
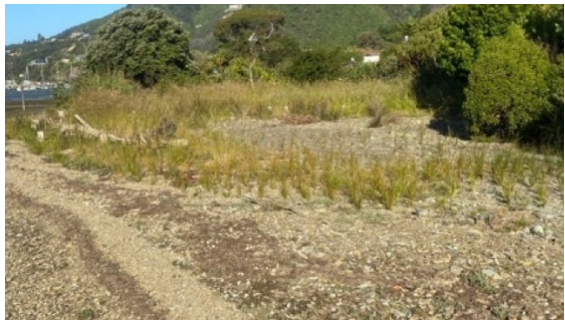
Fig. 4. Changes in intertidal and supratidal salt marsh over the 12 months since planting.

C. Intertidal searush in Zone 1	D. Supratidal searush and oioi in Zone 2
July 2020

Regular site visits were made after planting to assess success and to undertake site maintenance. The results are shown by way of comparative photos over time of representative parts of the restoration in Figures 3 and 4.

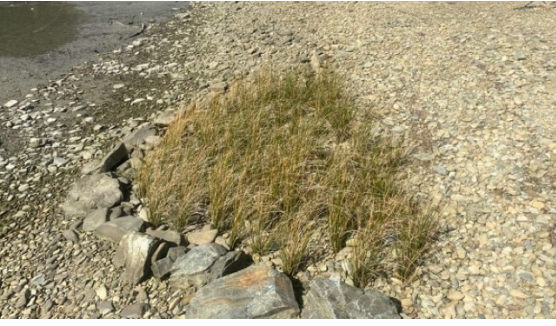
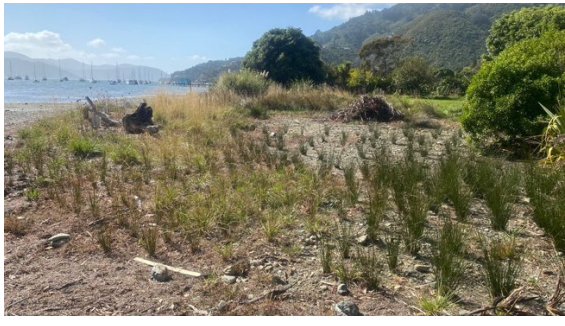
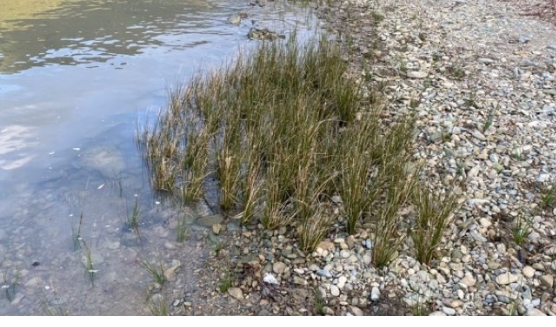
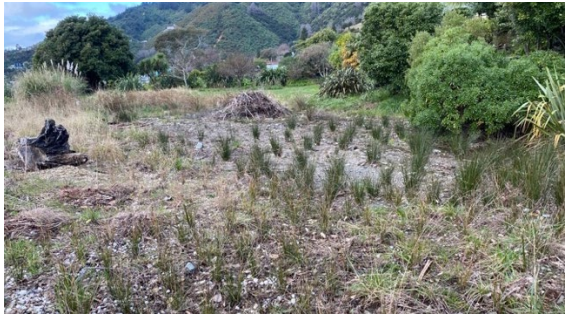
April 2021

July 2021

The planting of intertidal rushland behind chenier sills demonstrated that dense plantings were able to quickly establish and withstand prevailing conditions, despite being planted in mid-winter when plant growth is relatively slow. Planting root trainer specimens densely in deep narrow holes with plants well bedded into the sediment prevented losses from erosion in the intertidal area. Less dense plantings in more sheltered areas also demonstrated good survivorship. The intertidal plants showed more vigorous growth than those planted in the supratidal and terrestrial zones at the same time.

To ensure the ongoing success of the plantings it is recommended that 3-6 monthly site maintenance visits are continued over the next 2 years to manage weeds, repair chenier sills, and reset plant guards as necessary.

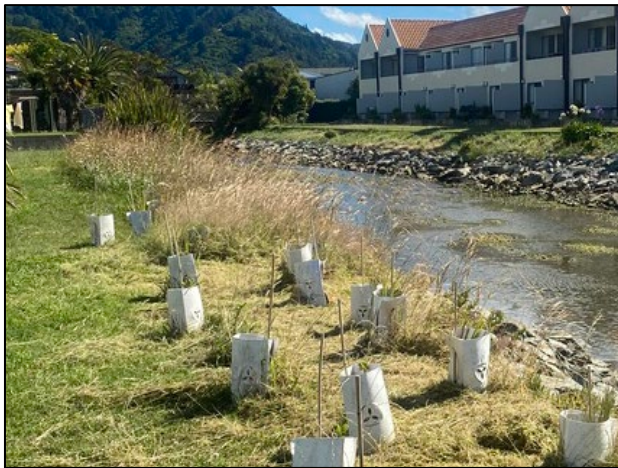
Weedeating around shrubs to reduce nuisance grass growth prior to spraying

There was little initial weed growth and consequently no spraying was undertaken prior to planting, and no site maintenance was deemed necessary over the subsequent five months. However, by December, five months after initial planting, weeds had begun to grow very extensively throughout the terrestrial areas. Where plant guards were used, it was relatively simple to locate and weed-eat around shrubs. Cut grass was then raked aside and glyphosate sprayed to prevent regrowth.

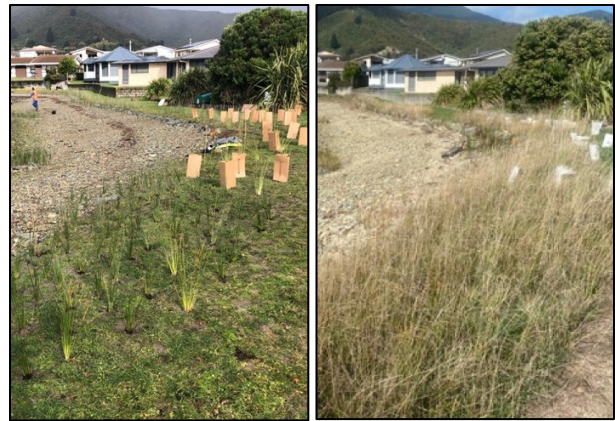
Dense plantings of rushes (left) were overtaken by grass (right) and were unable to be easily maintained by weedeater or spray methods.

Where rushes were planted in high densities it was not possible to weed-eat or spray grass without damaging the rushes.

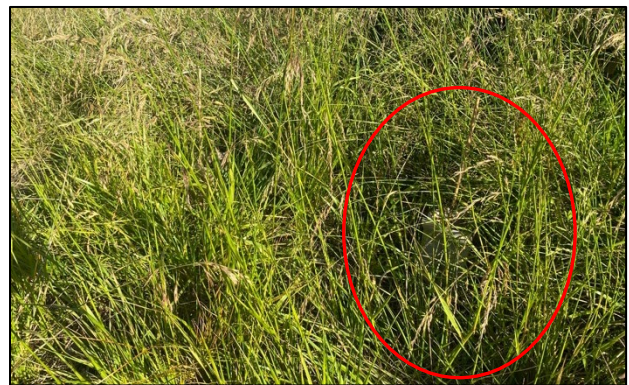
Grass overgrowth with red circle showing buried plant guard

Hand weeding was possible but time consuming and because individual rushes were not marked, it was difficult to relocate plants and avoid inadvertent damage while weedeating.

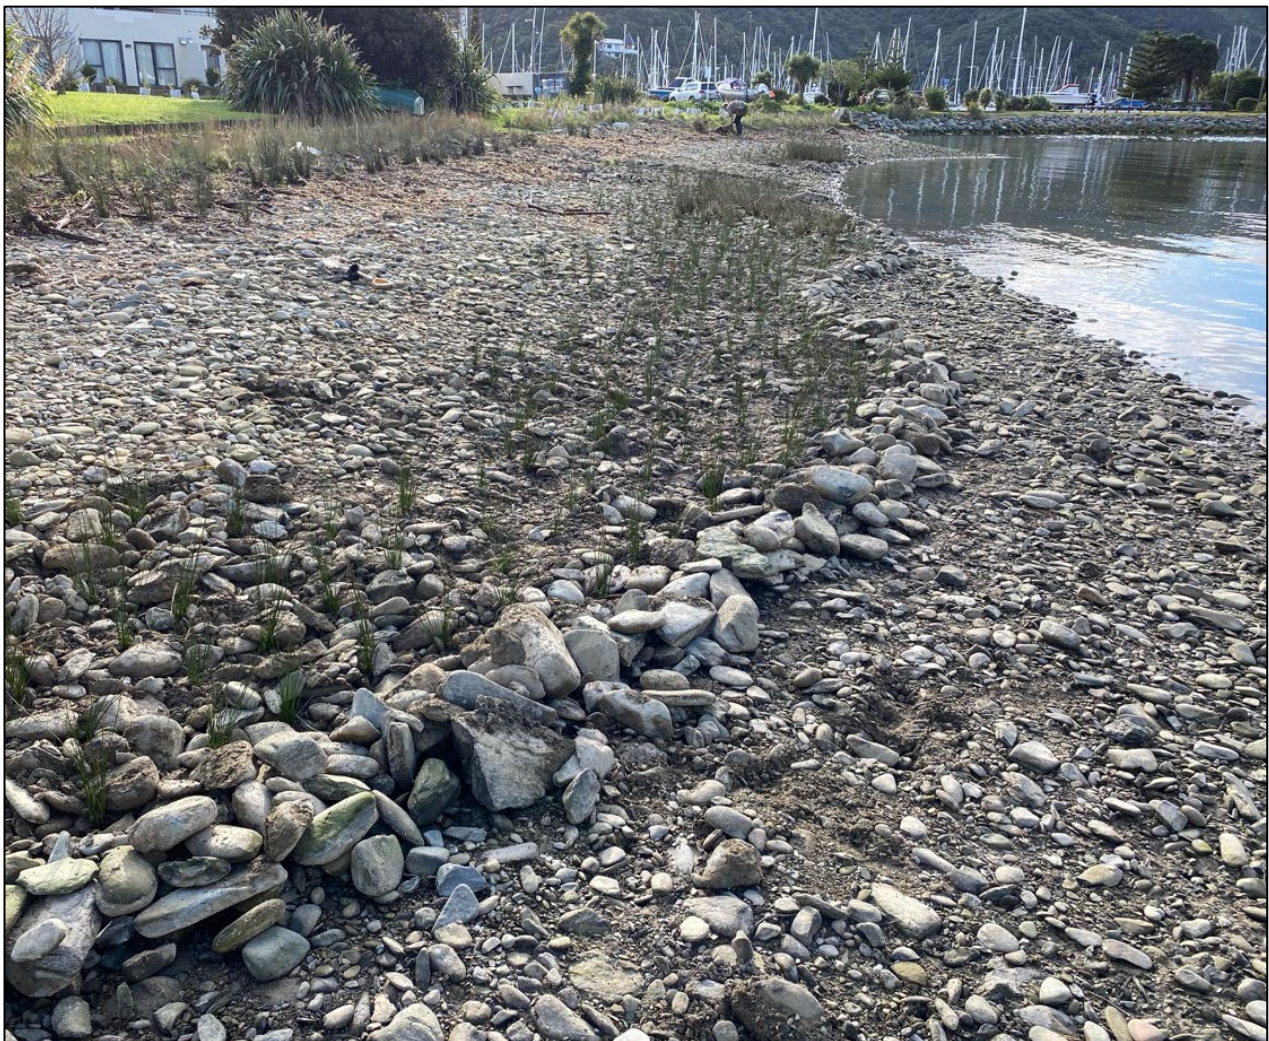
Intertidal rushland planted 20 July 2021
